Photographs of April 2021 Centrifuging Testwork reviewed by Ivan Saracik and Conleth O'Loughlin prior to completing Joint Statement dated 16 April.

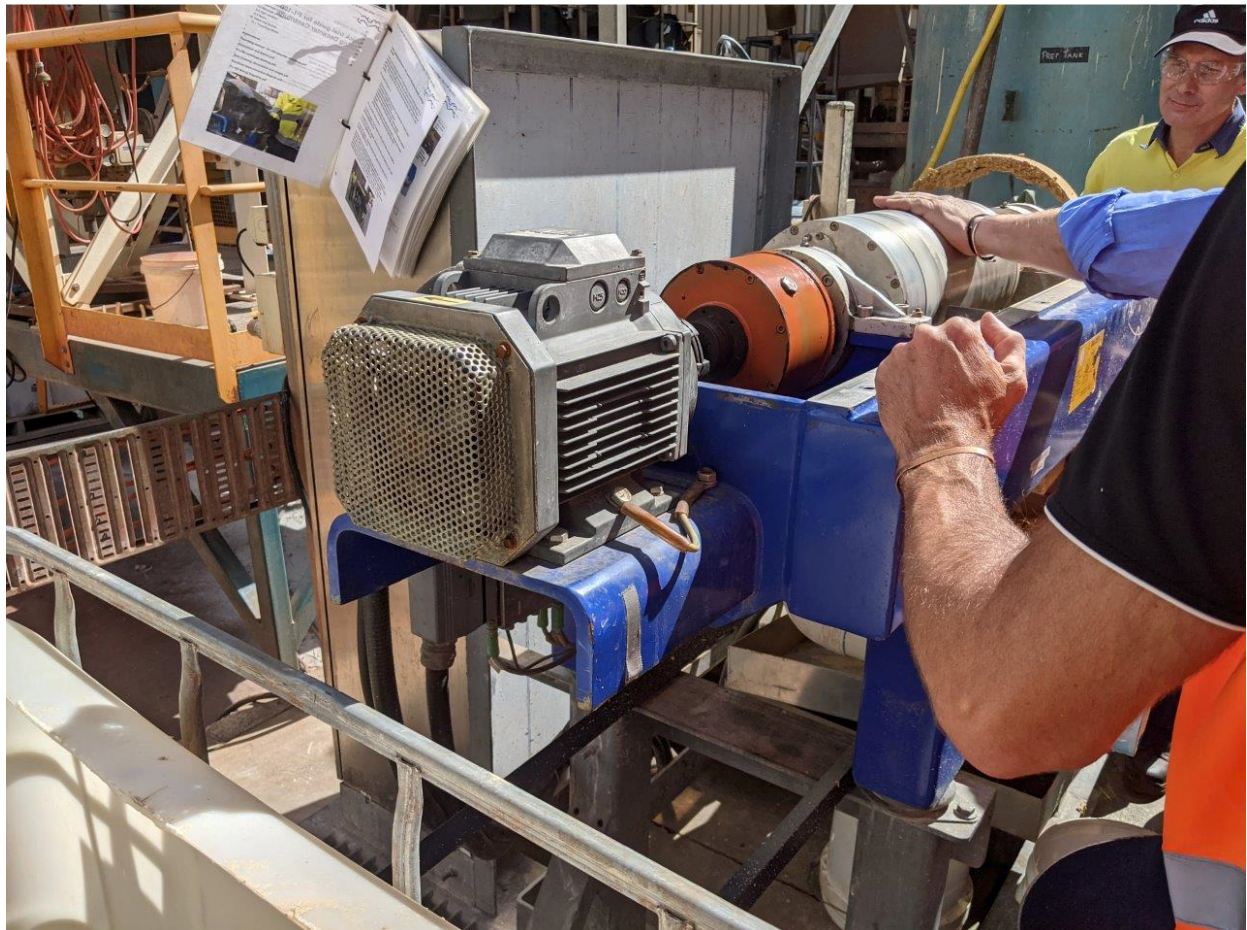
Picture 1.

Alfa-Laval P1-100 pilot unit centrifuge that conducted the test program in April 2021. The unit is shown with its protective cover open and the rotating assembly visible

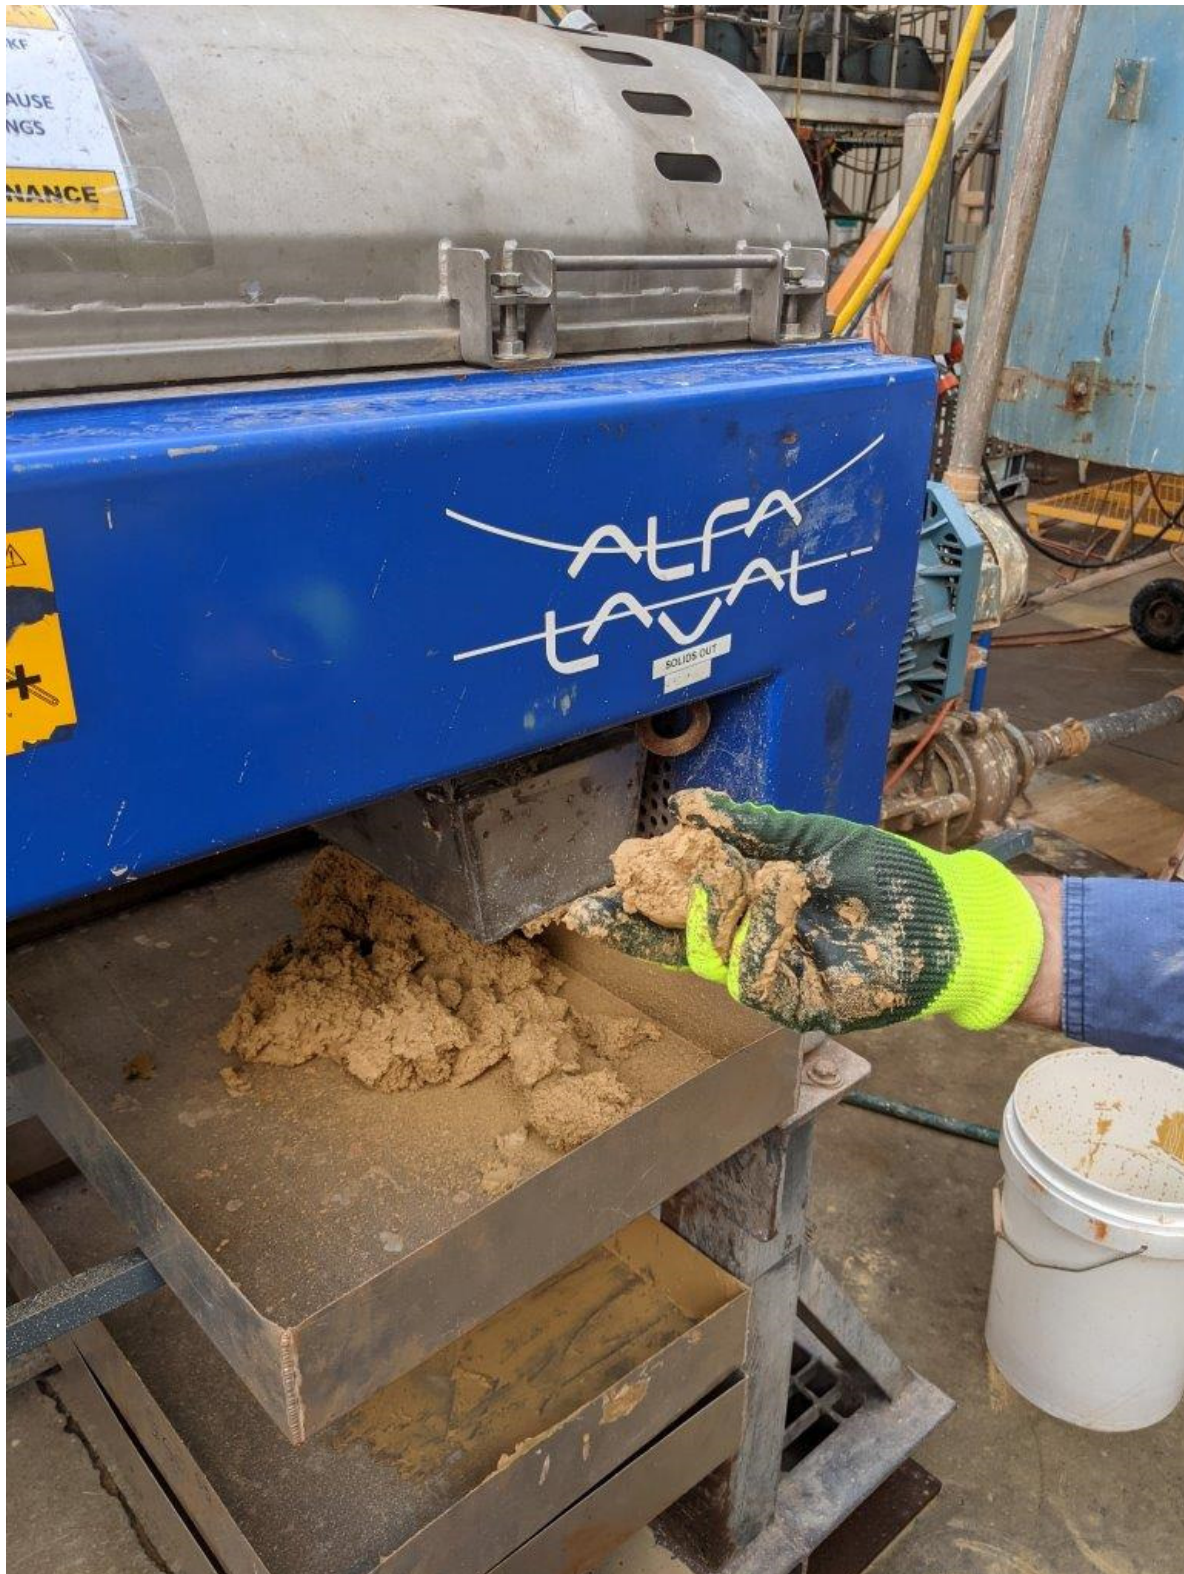
Picture 2.

The centrifuge carrying out a test and the cake as discharged can be seen. The operator is shown handling the cake immediately after discharge. It demonstrates that there is no surface moisture remaining after centrifuging.

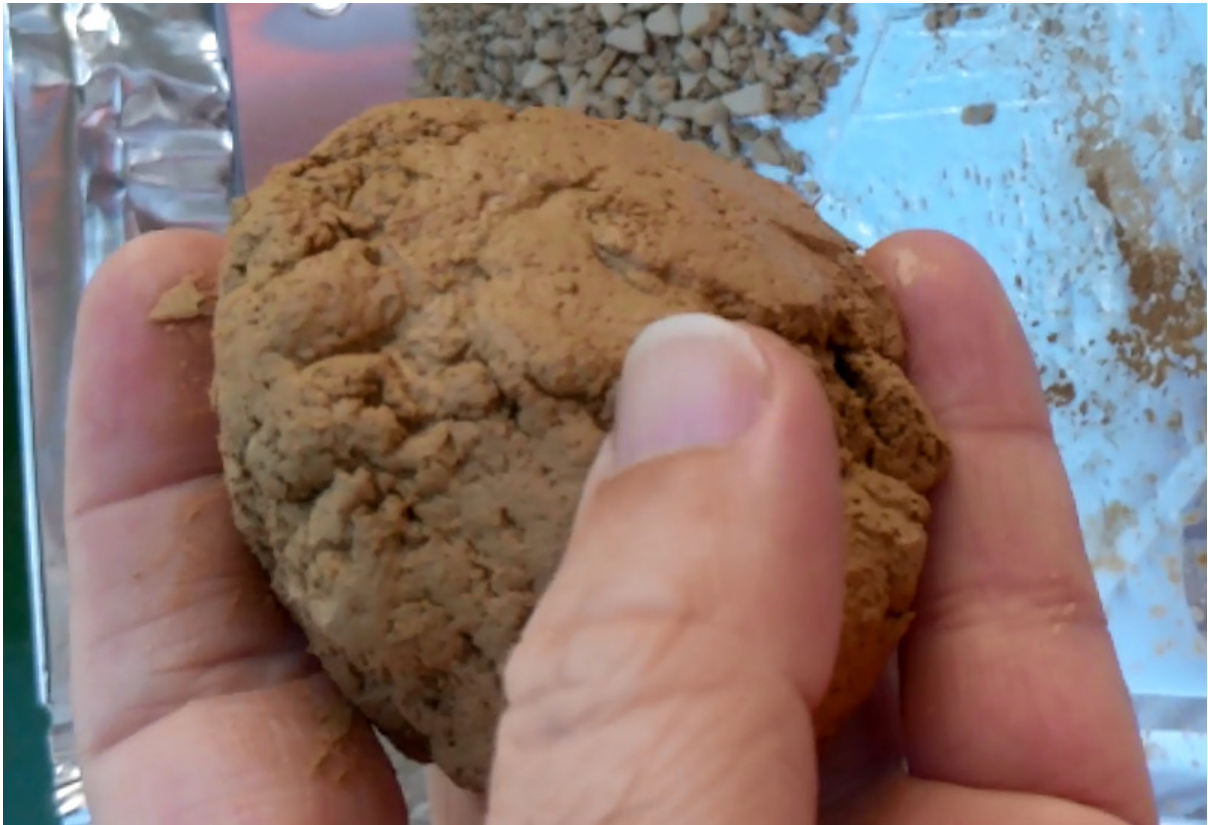
Picture 4.

A sample of the cake moulded by hand into a ball approximately 7 minutes after discharge from the centrifuge,

A ball of cake similar to Picture 4 but after a period of 24 hours, not 7 minutes. The ball was dropped onto the tray and showed no deformation.

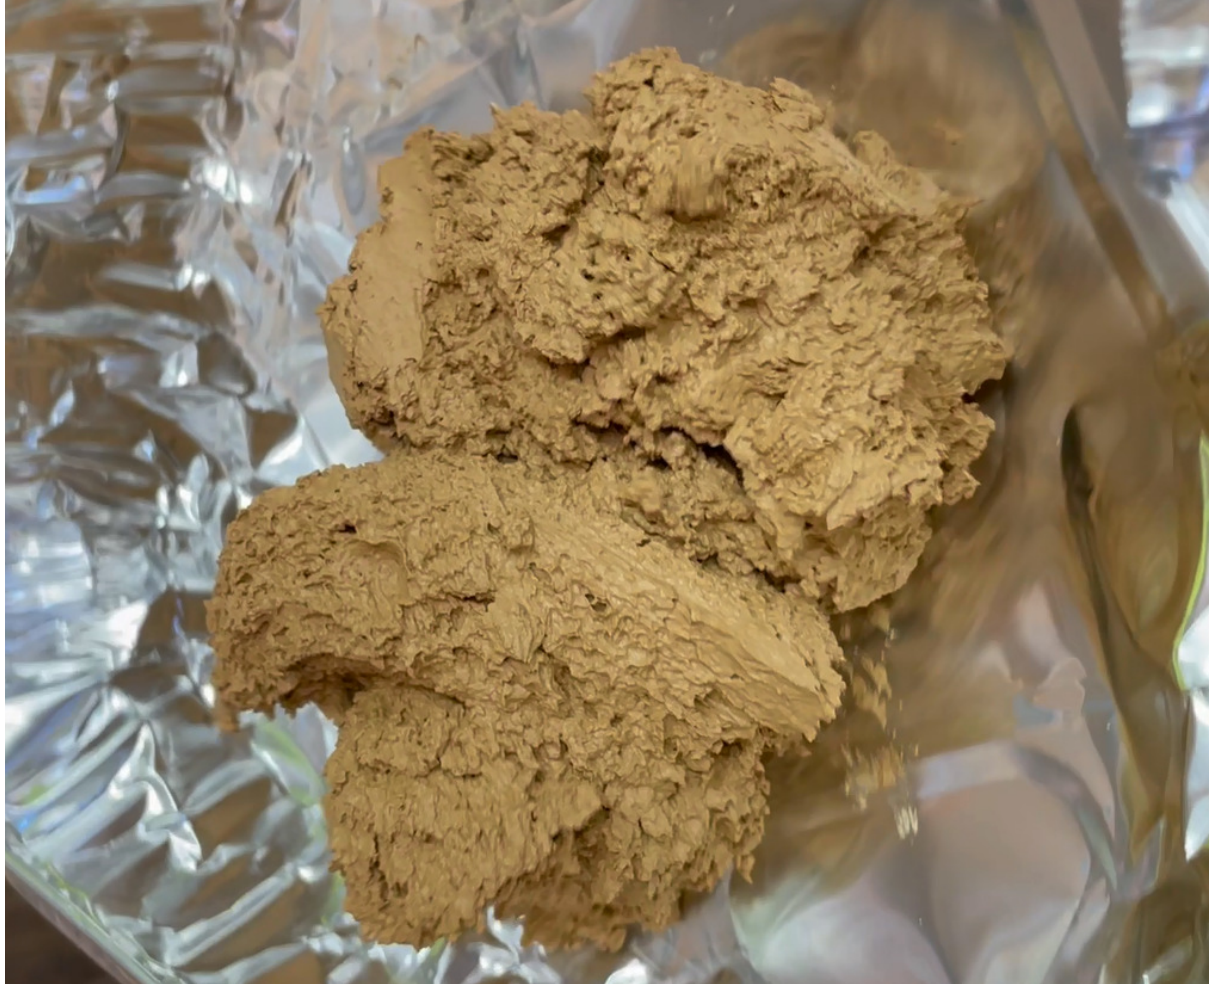
Picture 6.

A tray of newly centrifuged cake, subjected to intensive high frequency vibration and no free water was released to the tray.
