## Fingerboards Mineral Sands Project Inquiry and Advisory Committee Technical note

**TN No:** TN 031

**Subject:** Response to the IAC's third request for information (10 May 2021, Tabled Document 294), questions 2-5 relating to dam construction

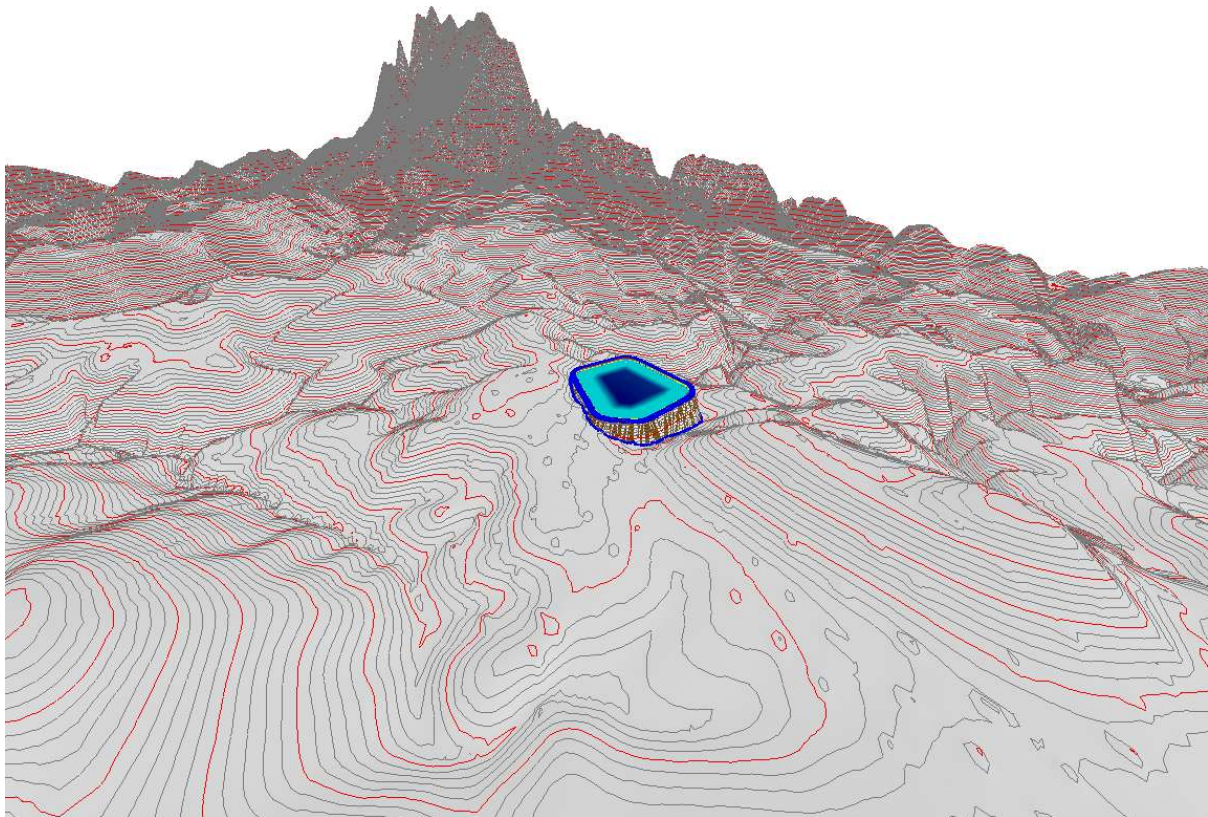
*Figure 14 - 3d View of WSD from the East*

The water storage dam (WSD) is located near the crest of the plateau and is surrounded by deep incised valleys as illustrated in **Figure 14** and **Figure 15** has been designed as a cut to fill, side valley dam, with crest embankment level of 125 mRL, with a storage capacity of 2.2 Mm<sup>3</sup>, of which 0.6 Mm<sup>3</sup> is located below the lowest point on the internal natural ground surface at 108 mRL, allowing for only 1.6 Mm<sup>3</sup> of water to be potentially realised from storage during a dam break scenario with up to 0.6 Mm<sup>3</sup> of embankment material. As the intent of the dam is a water storage dam, a spillway is not included within the design, with water levels in the dam controlled by pumping to the dam, with adequate operational allowance for incipient rainfall storage from a storm event up to an including the PMP. Thus whilst unlikely during operation, failure due to overtopping is modelled in this dambreak scenario. The maximum height of the dam is 22.5m relative to the downstream toe of the embankment, and 17m relative to the natural surface under the embankment.

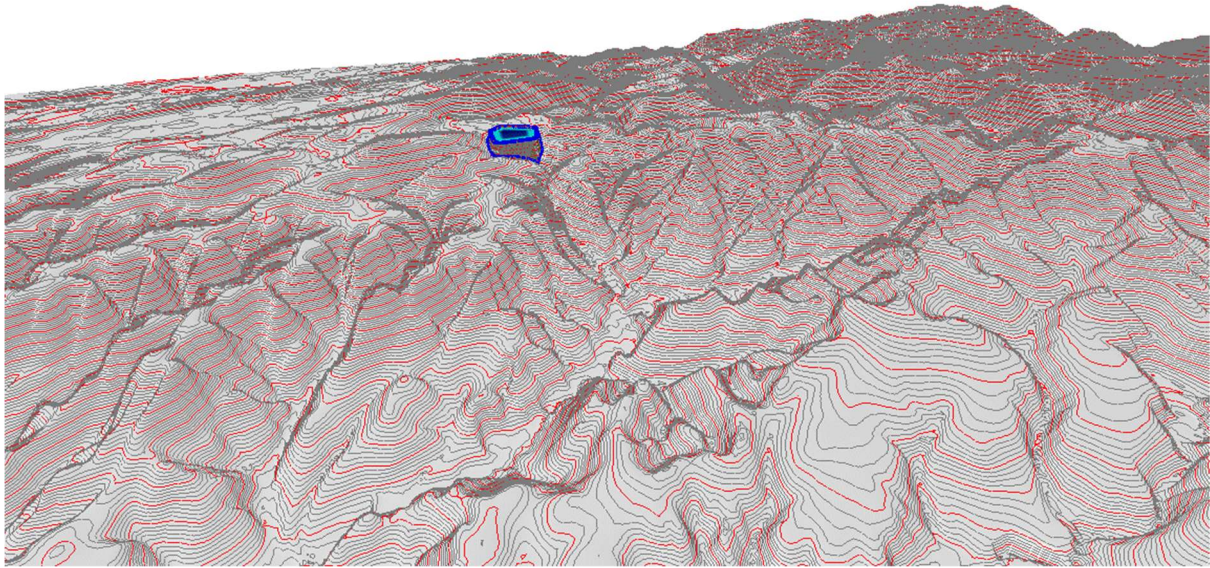
*Figure 15 - 3d View of WSD from the North East*
